PROJECTS.

1 EXAMPLES OF PAST SOIL STABILISER PROJECTS

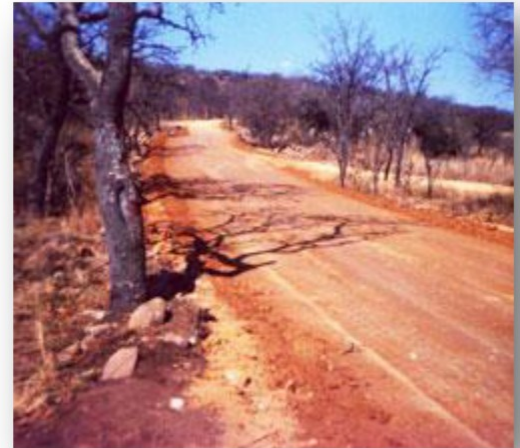
4. Natural SOIL STABILISER Slab, Vaalwater, Limpopo Private Game Farm – 2001

4 km – 3% 100mm SOIL STABILISER Slab roads were constructed on the game farm with relatively fine Kalahari type sand. No bitumen seals were used to retain the natural beauty of the Bushveld. A huge dam was then constructed with many Bells trucks hauling rocks to the dam wall over these roads, designed for lighter traffic. The durability of the roads was rated excellent, despite some wear on sharp bends between thorn trees caused by the twin rear axles/wheels of ADTs. The higher dosage, thicker layer straight section showed hardly any wear.

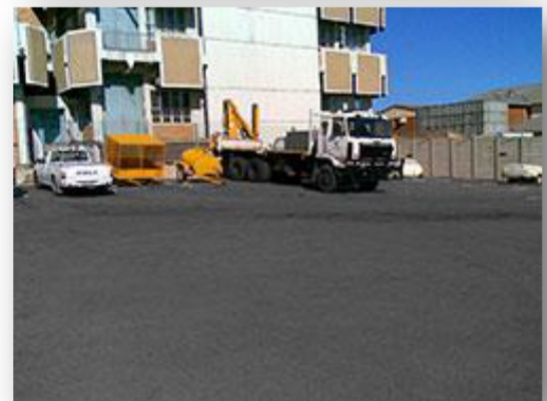
5. Black Top SOIL STABILISER Slab, TFMC, Kempston, Port Elizabeth – 2002

A 100 mm thick 3% SOIL STABILISER Slab was constructed in 1999 at TFMC, Kempston PE for an entrance road and hard stand to load / off load / store heavy machinery. A 30mm asphalt seal was added and is still in excellent condition 14 years later despite heavy use.

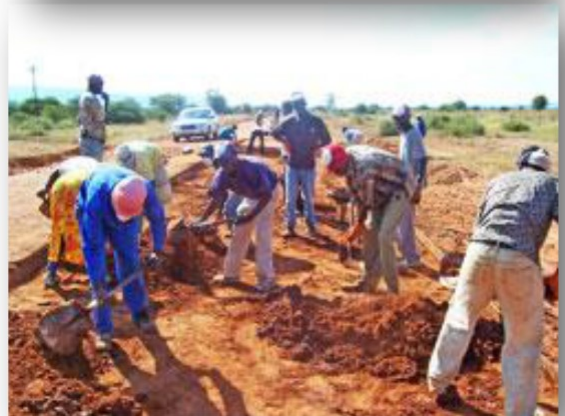
6. Black Top SOIL STABILISER Slab near Mokopane, Limpopo ILO / CSIR / Limpopo Province – 2003

A 150 mm thick Natural SOIL STABILISER Slab Provincial Road Section was constructed in two 75mm layers labour intensively on a 3% CBR sub-base. The lower part of the base course used 2% SOIL STABILISER dosage and the upper section 2.8% dosage. CSIR tested 296% CBR strength 6 weeks after construction. Water poured onto the surface does not penetrate but runs off the surface. A bitumen seal was added later (which required only 60% CBR support strength). The construction team of 30 workers was slightly cheaper than using a water truck, grader and roller. Thirty (30) teams would be faster than mechanical construction and slightly cheaper.

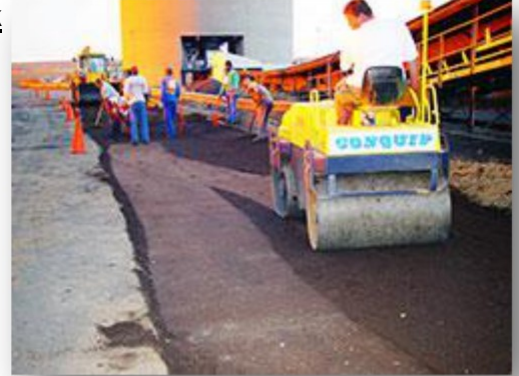
10. Black Top SOIL STABILISER Slab New Denmark Colliery Haul Road Eskom - 2004

This coal truck haul road used only 1% SOIL STABILISER dosage in a 150mm sub base on metres of heaving clay and 2% SOIL STABILISER 150mm base course under an asphalt seal. Coal trucks have been using the road for 7 years. The previous road failed regularly as the cement stabilization was too rigid and brittle and cracked when the clay road bed moved. SOIL STABILISER's water resistance keeps more water out of the lower layers, causing less movement of the clay and is somewhat elastic to accommodate some motion but stiff enough to carry the heavy loads.

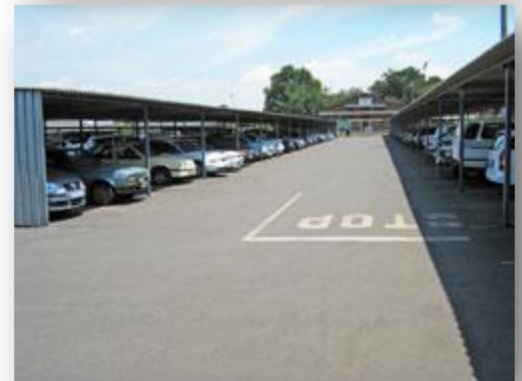
11. SOIL STABILISER Slab Parking Lot Meyerton (BHP Billiton / Samancor / AGC Eng) - 2004

A large parking lot with an asphalt seal in excellent condition after 7 years (no maintenance). On site manganese waste was utilized as aggregate for stabilization

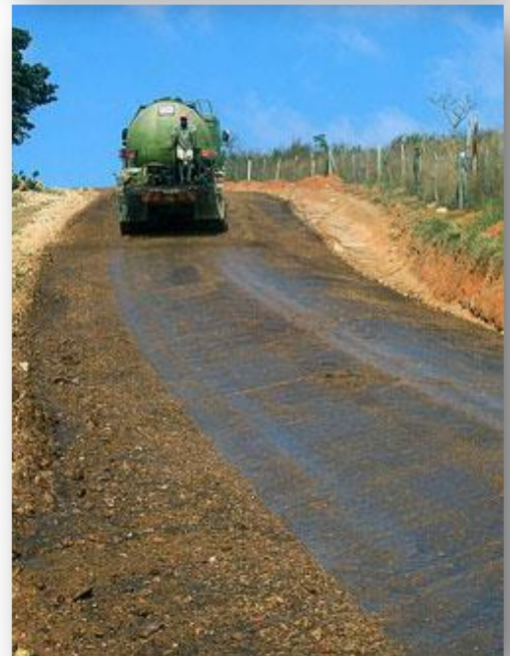
12. Natural SOIL STABILISER Slab / Seal, Piggs Peak, Swaziland (Swazi Government / ZMCK Eng) - 2005

3km SOIL STABILISER Slabs and Seals constructed on steep Drakensberg slopes with severe drainage problems. The road surfaces were strengthened considerably (no bitumen seal) with excellent engineers report (ZMCK). The SOIL STABILISER Slab (mix in) and SOIL STABILISER Seal (spray on) lasted for 6 years without maintenance. Concrete side drains washed away in many sections.

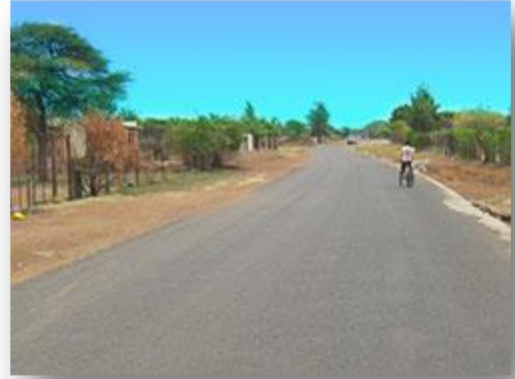
13. Modikwe SOIL STABILISER Slab Road, Northwest Province – Dec 2005

3.5km x 7m x 100mm 2.4% SOIL STABILISER Slab was constructed by an emerging contractor and Mahlangu Consulting engineers near Rustenburg (both went out of business and the Rustenburg (district) Council completed construction. Lab tests at Rustenburg showed excellent C3 strength. A 6.7mm bitumen slurry seal was added onto the SOIL STABILISER Slab base course. Still in good condition after 11 years.

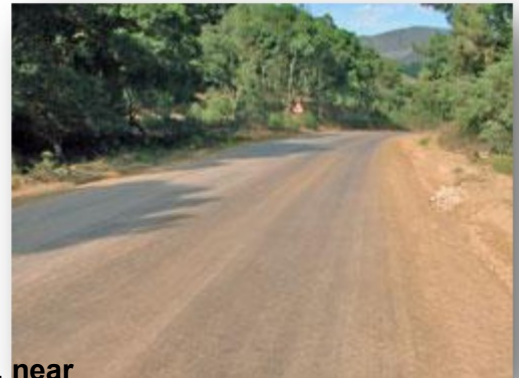
15. Black Top SOIL STABILISER Slab, Caledon /Hermanus (PD Naidoo / Overberg Council) – 2007

A 100 mm 2.5% SOIL STABILISER Slab just below a mountain pass was constructed under a bitumen double seal. After heavy rain and traffic it is in good condition and should provide very low life cycle costs with low maintenance for many years.

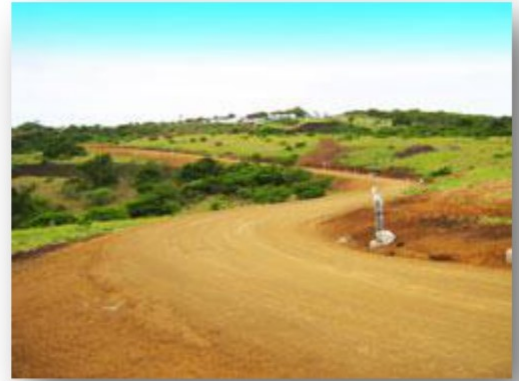
17. SOIL STABILISER Natural Slab, Chintsa, East London (Lukhozi Engineers / Pam Golding Development) 2007.

A 3.5km x 7m x 150mm, 2.7% SOIL STABILISER Slab wearing course was constructed by Robert Bros / Lukhozi Construction Engineers. Despite heavy rain during construction the imported Sabunga gravel was considerably hardened and water proofed by the SOIL STABILISER polymers to carry the design traffic without a bitumen seal. This preserves the natural look of the beautiful environment.

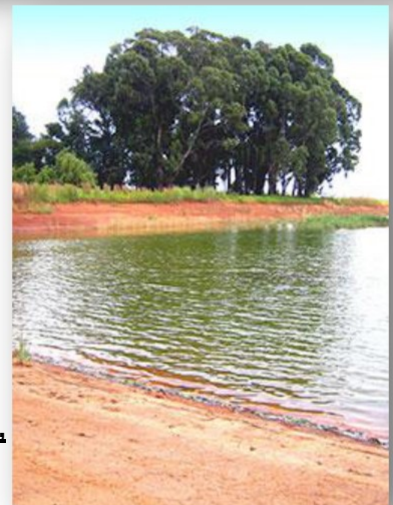
18. SOIL STABILISER Slab Pond Lining, Bapsfontein, Gauteng - 2007

A 75mm thick, 3.3% SOIL STABILISER Slab was used to line the sides of a 20 000m² dam which could never before be filled due to excessive leaking. The dam is now full (3m deep) with no leaks. This is an indication of the water resistance of SOIL STABILISER and the protection it provides to roads pavement structures where layers stay strong despite moisture and keeps lower layers dry and strong.

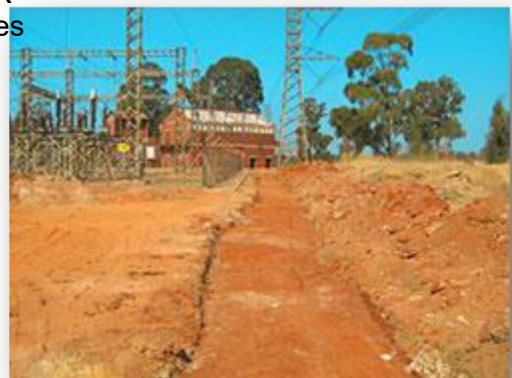
19. SOIL STABILISER Cable Trench Protection, Boksburg, Ekhuruleni, Gauteng, 2007

10km x 1% SOIL STABILISER Cable trenches were backfilled with SOIL STABILISER reinforced soil and a 3m wide 75mm + 75mm thick 1.2% / 2.4% SOIL STABILISER Slab inspection road was constructed over it. This provides quick access for patrol vehicles. Not a single cable theft was reported since installation and many other trenches have / are being protected with SOIL STABILISER.

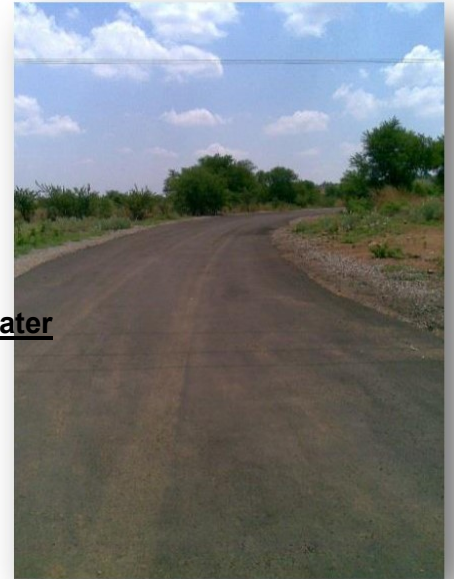
20. SOIL STABILISER low dosage slab selected layer, Qumbu, Eastern Cape (Madan Singh G Bester Eng. / Haw Inglis Construction - 2008

A 23km provincial road north west of Qumbu required improved selected layer support under the sub base in moist areas next to hill sides. 3.5km x 150mm thick 1% SOIL STABILISER Slab was mixed into the selected layer with considerably increased strength and water resistance. This helps to ensure adequate support for the sub base, base and bitumen seal and balances the pavement structure. This low dosage helps to prove that SOIL STABILISER can support low traffic road sub / base and bitumen seals.

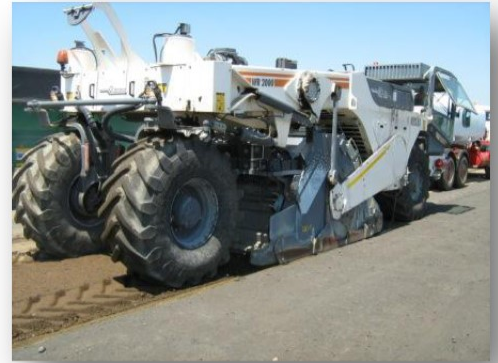
25. SOIL STABILISER Insitu road recycling - Eskom & Bigen Africa - 2010.

In-situ recycling of 9km of an old, unusable provincial road using 0,5% SOIL STABILISER. The road carries approximately 2000 coal trucks per day. Initially designed as a 3 month temporary road, it has been in service for 9 months. An additional SOIL STABILISER base course is to be added and surfaced with a bituminous seal for long term use.

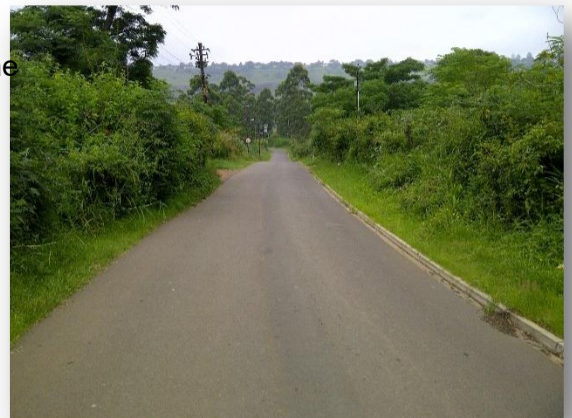
26. SOIL STABILISER Urban Road – Stockville road, Pinetown, Ethikweni Municipality, Tau Ya Mariri Construction Jan 2010.

Reconstruction of an old, unusable urban road using 2,5% SOIL STABILISER. The previous asphalt, ETB and concrete road had failed and a 150mm SOIL STABILISER base course was installed and surfaced with asphalt. A short section at Carnation place was also reconstructed using the same design.

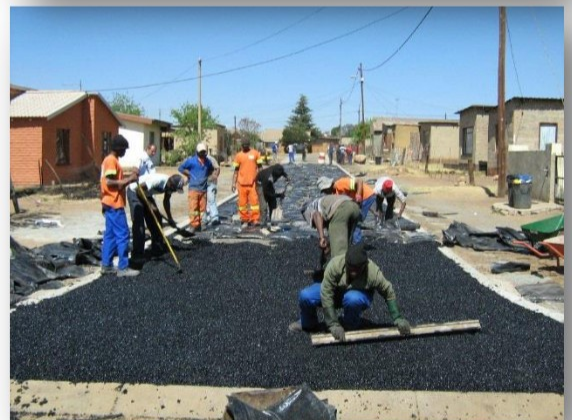
27. SOIL STABILISER Wearing course – Rabie Ridge, Johannesburg Roads Agency, Stevrob Construction July 2011.

G6 material was imported on top of an existing failed gravel road to allow all weather access for the local community. With a 3% SOIL STABILISER StabilMix dosage, mixed into a 100mm aggregate layer, an effective and durable wearing course was provided.

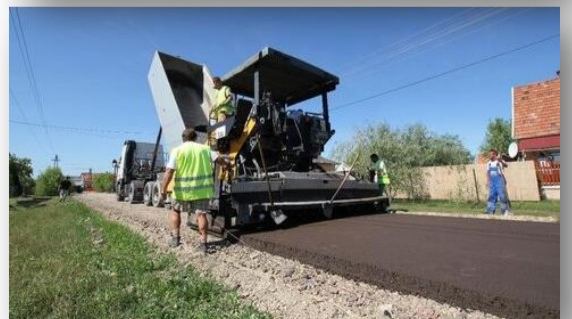
28. SOIL STABILISER E-Base – Parys 2012 – Freestate Provincial Government – Thutela Bogolo

A 2% SOIL STABILISER 100mm E-Base road was constructed in the township and sealed with 25mm cold-mix asphalt. A lighter seal was also found to be feasible, e.g. 7mm bitumen slurry seal.

This proved to be an ideal, durable low traffic volume solution which can create much employment and improve conditions for many communities. This road design can extend existing road budgets further.

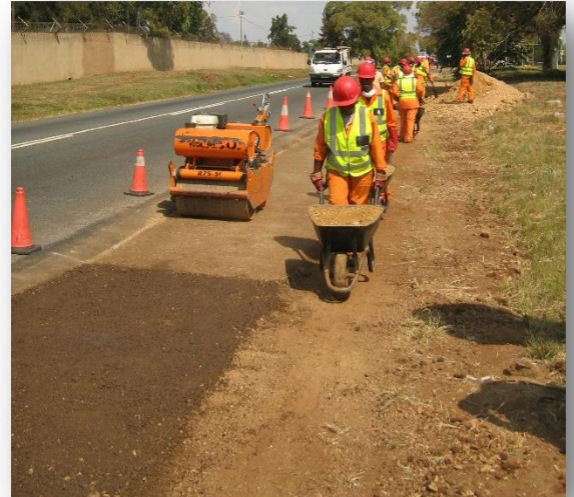
**30. SOIL STABILISER Road Shoulders –
Zwartkops Pretoria (2012) - EPWP**

Dangerous edge-breaks and drop-off occur regularly on the Old Johannesburg Pretoria road as the gravel road shoulders erode and wash away regularly. SOIL STABILISER was mixed in labour intensively, placed and compacted. It reinforced the road aprons considerably and greatly reduced or eliminated erosion and costly re-graveling. This application can create sustainable job opportunities and reduce road shoulder maintenance costs. Persons trained to do this can then also construct bicycle and pedestrian paths, side-walks and many other SOIL STABILISER applications.

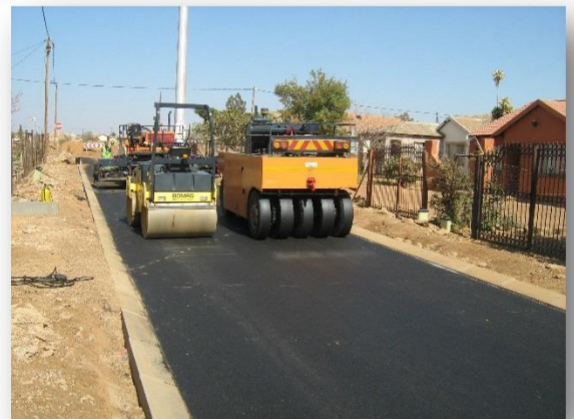
**31. SOIL STABILISER Base Course –
Soshanguve Pretoria (2012) – Superway
Construction – City of Tshwane**

Nyeleti Engineers designed a pavement structure around a 2% dosage SOIL STABILISER BituForce base that reduced the overall cost of the road by approximately 30%. Such a significant saving could allow the construction of significantly more roads with the same budget. Tests showed exceptional UCS & ITS strengths even after soaking. Tshwane City Council is satisfied with the quality of the 11km of roads constructed roads through to 2015 and continues to reorder and benefit from SOIL STABILISER.

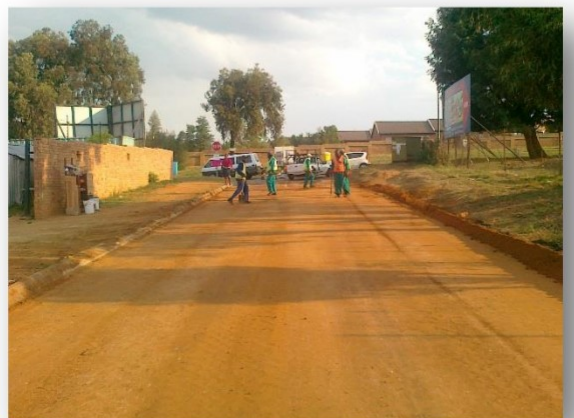
**32. SOIL STABILISER Base Course –
Radiokop (2012) – Johannesburg Roads
Agency – Lidwala**

An SOIL STABILISER BituForce base-course was designed for JRA by Lidwala consulting engineers for several urban road sections in Johannesburg. Sealed with 30mm hot-mix asphalt these roads eased service delivery in an economical and effective way.

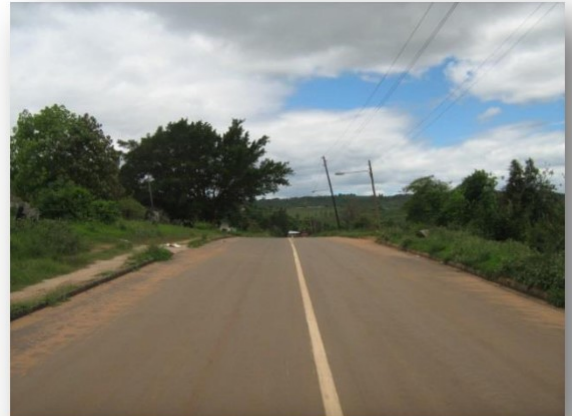
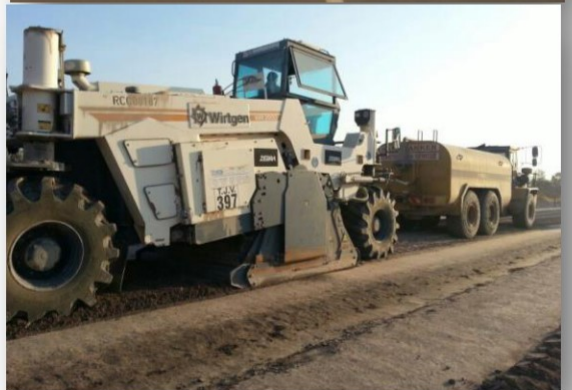
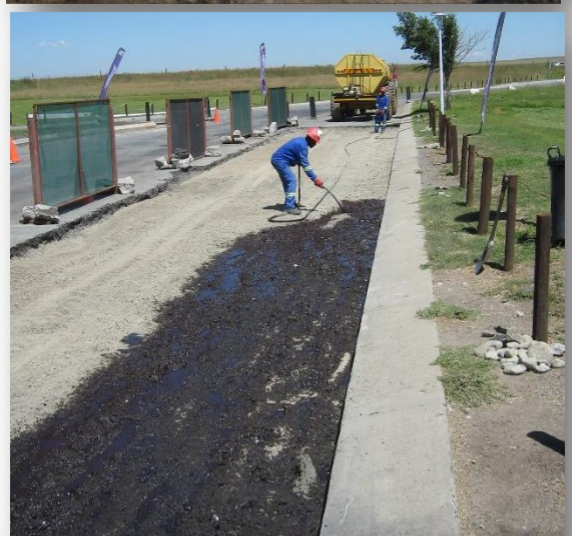
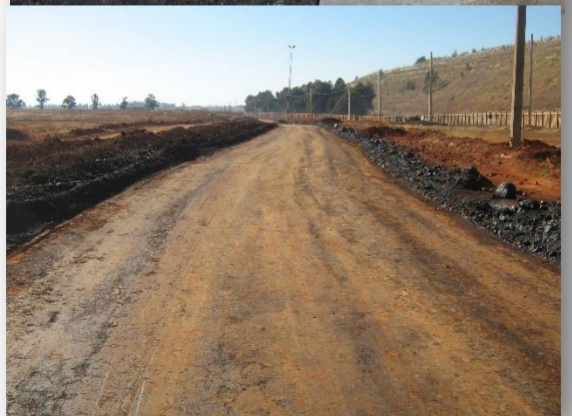
**36. SOIL STABILISER Dust Control –
Westonaria Landfill (2013) – ProPlan
Consulting Engineers – Specplan
Construction**

An SOIL STABILISER ModSpray with 0.5% dosage, 150mm deep was constructed on unstable sub-layers leading to a refuse-dump used by the council and the nearby mine. This wearing course design is maintained by spraying SOIL STABILISER SprayOn onto the surface when and where required. This has not been required for almost 2 years. It is significant that the SOIL STABILISER reinforced soil can bend and return under loads without cracking as it is non-continuously bound.

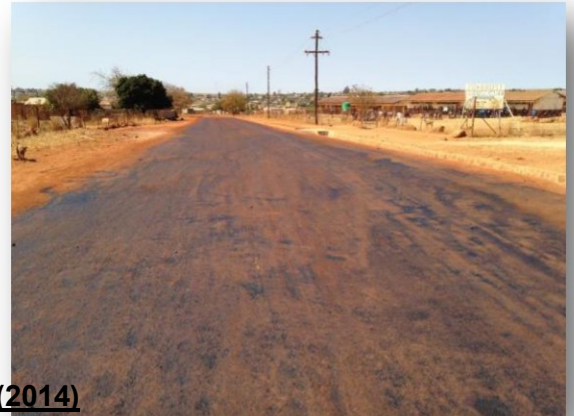
**37. SOIL STABILISER Dust Control –
Kwamahlanga Municipality (2013)**

The SOIL STABILISER SprayOn is a new and unique way to control dust and reduce erosion of gravel road surfaces in township and rural areas. This improves the quality of life of the community and reduces the maintenance cost of regular grading and re-gravelling. The surface must be maintained with ReSprays as and when required. The frequency depends on the traffic, climate and soil type used.

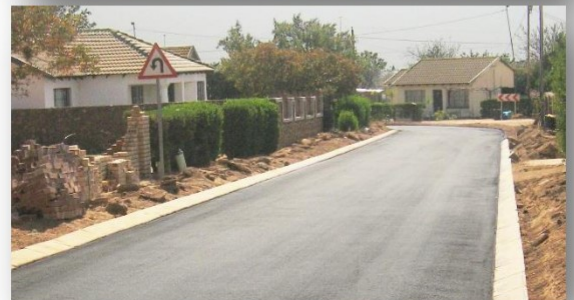
**38. SOIL STABILISER Base Course – Soshanguve (2014)
– City of Tshwane, Boitshoko/Vharanani
Construction**

This road is part of the ongoing construction of roads in Soshanguve by Tshwane City Council as stated previously.

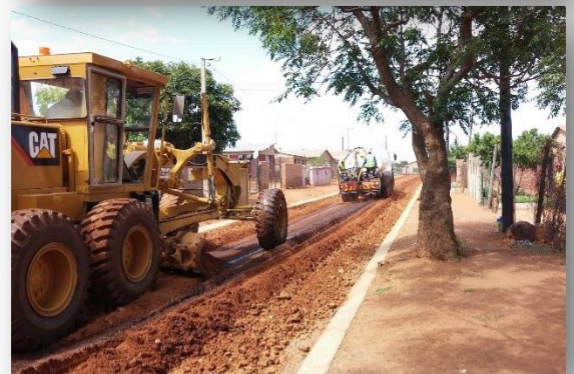
**39. SOIL STABILISER Base Course –
Mogale City Municipality (2014)**

Following the success of the SOIL STABILISER roads in Soshanguve, Mogale city decided to test SOIL STABILISER at a SANAS accredited laboratory and constructed a road of similar design. The laboratory tests showed excellent wet strength and the council was very satisfied with the completed road. The council is specifying SOIL STABILISER BituForce roads in future projects.

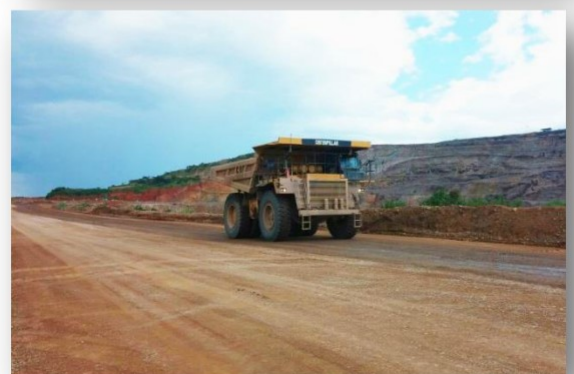
**40. SOIL STABILISER Dust
Control – DRC -
FreeportMcMoRan (2015)**

This 200 ton Caterpillar 777 off-highway haulage truck leaves no or very little dust while travelling on the SOIL STABILISER SprayOn treated haul road. This is to be maintained by regular SOIL STABILISER Micro Sprays with very low dosage at low cost. Such ReSprays can often be done only once or twice a week where dust inhibitors that rely mainly on water sprays to inhibit dust would be needed at least 21 times per week at much greater cost.

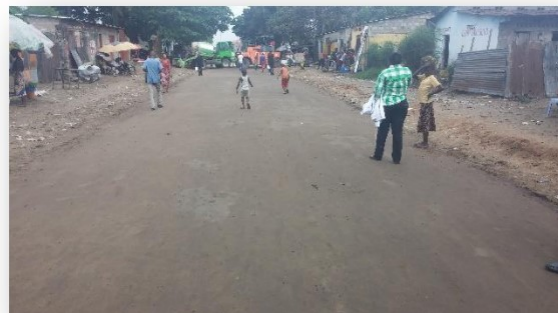
41. SOIL STABILISER Base Course – DRC Roads Authority (2015)

In situ-stabilization of an un-cohesive sand for an urban road in Kinshasa, surfaced with a bitumen slurry seal.

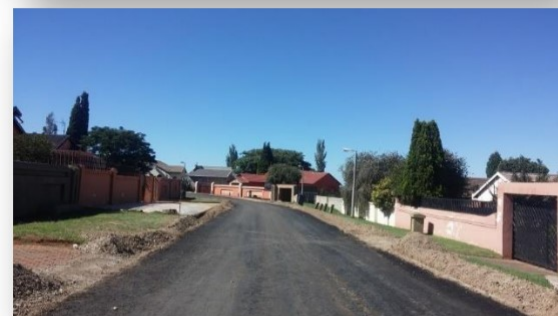
42. SOIL STABILISER Base Course – Zakkariya Park (2016) Johannesburg Roads Agency – Acto-Phambili / CMP / Nyeleti / Primat

In situ-stabilization of existing surfaced roads in Johannesburg, surfaced with an asphalt seal.

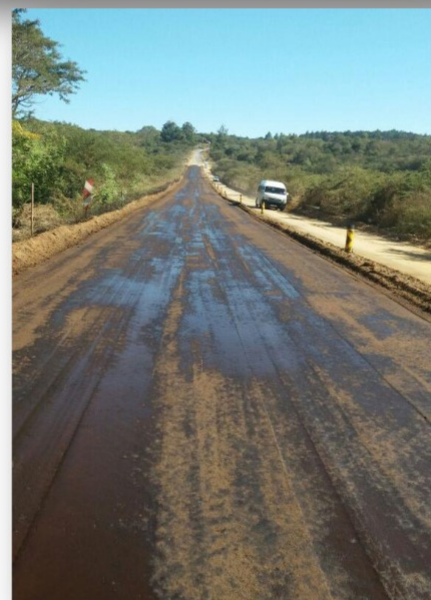
43. SOIL STABILISER Dust Control – Elim (2016) Roads Agency Limpopo – Inyatsi Construction – Nyeleti Consulting Engineers

SprayOn dust control of gravel roads by-pass lanes during re-construction of the provincial road.

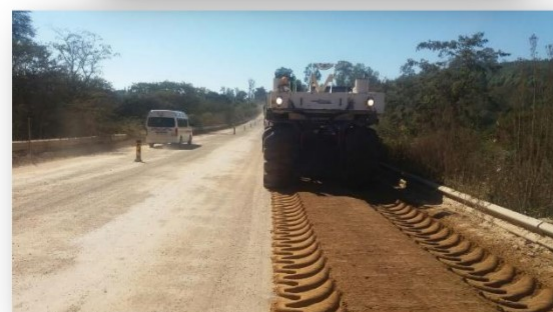
44. SOIL STABILISER Base Course – Elim (2016) – Inyatsi Construction – Nyeleti Consulting Engineers

In-situ stabilization of a provincial road for RAL. Existing road pavement structure was retained and the top 200mm and surface was milled into the pavement. This was then Primed and Re-Sealed.
